Name Of Dam: WESTERN BRANCH RESERVOIR
Location: CITY OF SUFFOLK
Inventory Number: VA. 12311

PHASE I INSPECTION REPORT

NATIONAL DAM SAFETY PROGRAM

DEWARD M. MARTIN & ASSOCIATES
WILLIAMSBURG, VIRGINIA
AUGUST, 1979

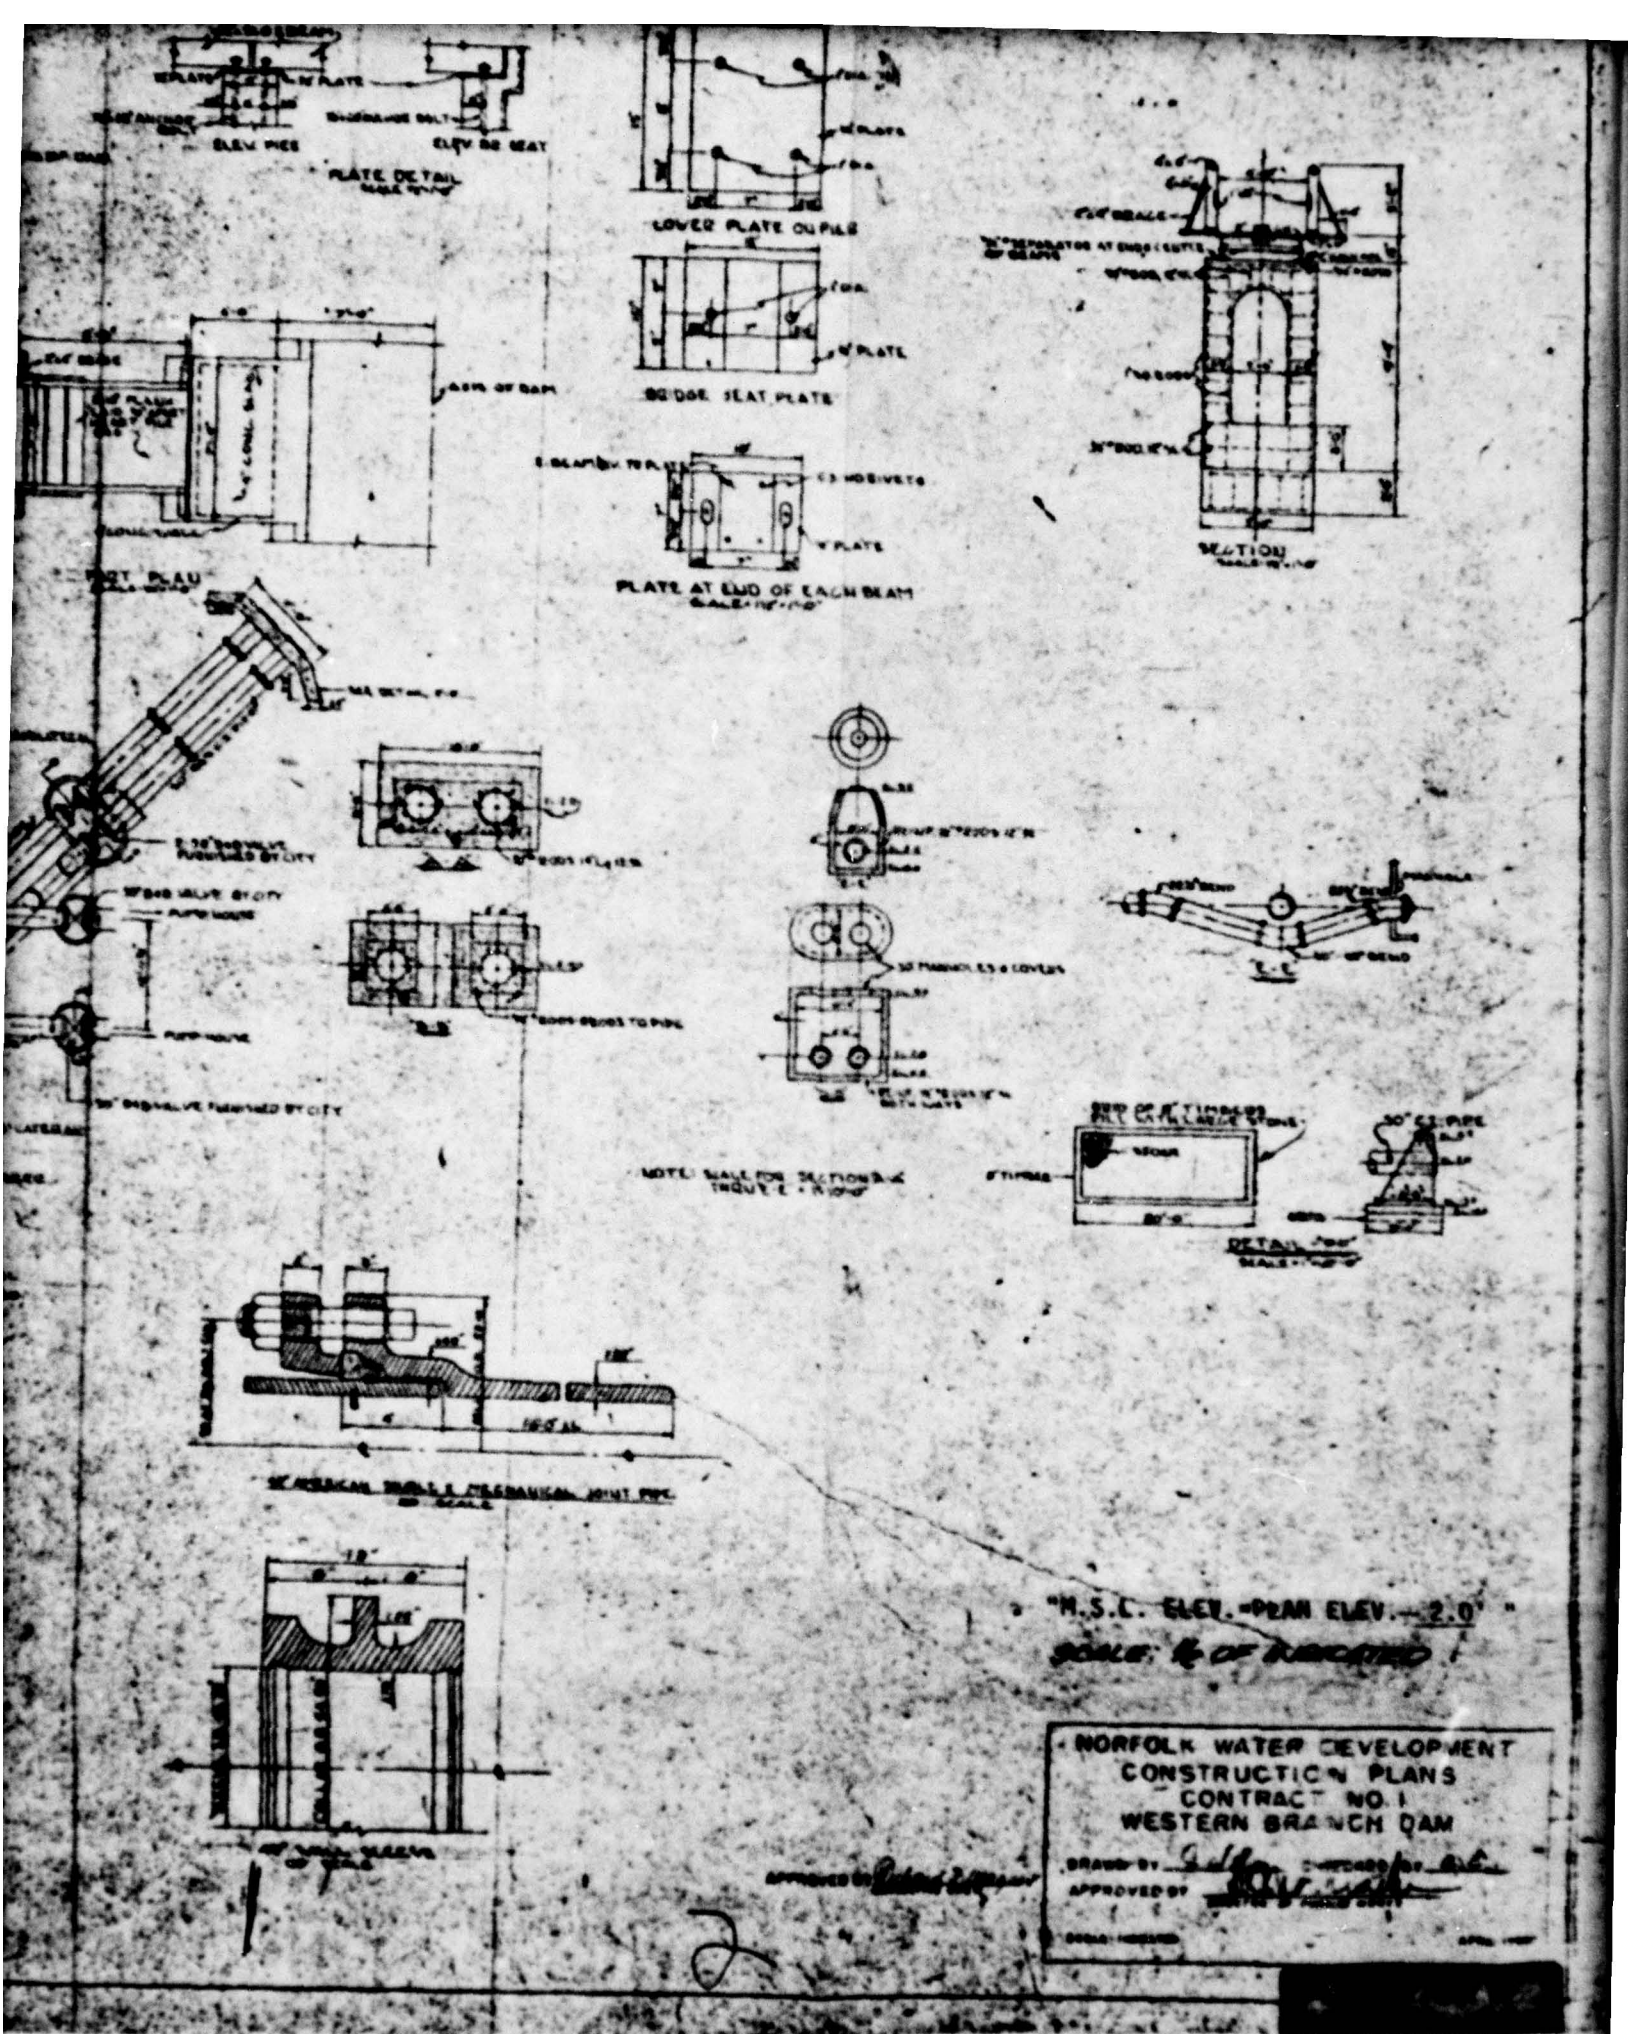
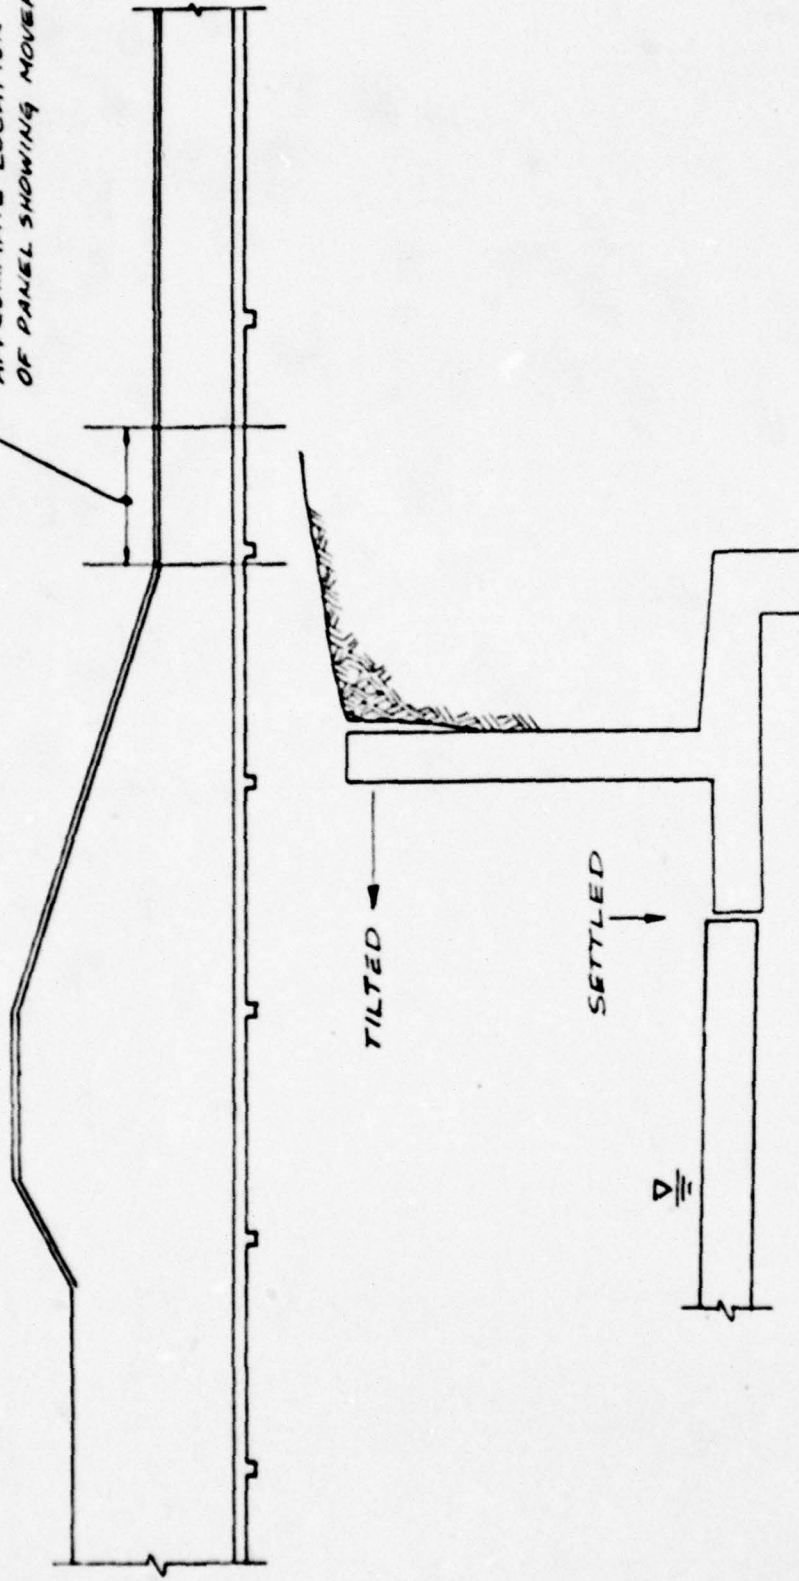
PLATE NO. 7

3.1.4 Spillway: The concrete spillway shows evidence of surface spalling. Settlement and tilting was observed in a retaining wall panel on the north side of the spillway (see Plate 7, Appendix I). The top of the panel has tilted forward, and the front of the panel's base has settled. Both have moved about two inches.

APPROXIMATE LOCATION
OF PANEL SHOWING MOVEMENT

- c. Determine if the settlement and tilting detected in one panel of the north side of the spillway channel is still occurring. If movement is still taking place, the owners engineer should recommend remedial measures designed to prevent failure of the wall.

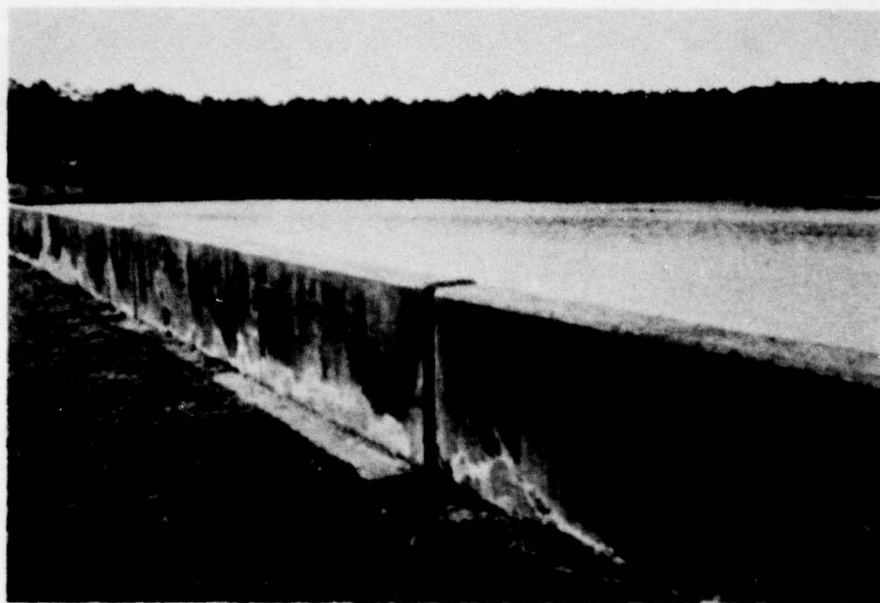
PHOTOGRAPH NO. 3
Parapet

*3.1.3 Appurtenant Structures: Settlement of the wall (parapet) running along the crest of the dam was observed approximately 400 feet to the left of the intake tower. The area of settlement consists of two panels which have settled, forming a slight dip in the wall where they intersect.

The pondered water located at the toe of the embankment could cause the soil to become soft and muddy unless the drainage conditions are corrected. The settlement in the parapet wall appears to have occurred some time ago and does not show signs of recent movements or major structural damage. Settlement and tilting detected in one section of the spillway wall may, if movement is still continuing, indicate potential failure of that section of the wall.
